Manhole Inspection Summary

Manhole # S04YY1012MH

Location Address: **6507 WILLIAMSON AVE**

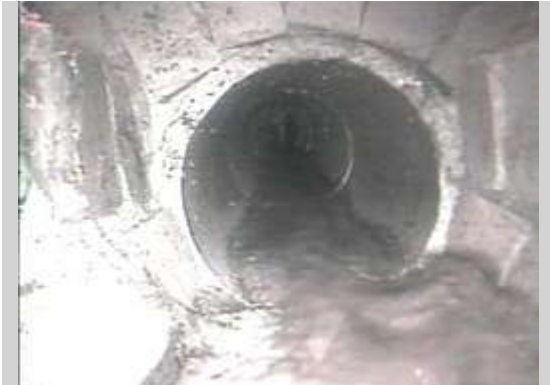
10 in. Circular Gravity Sewer Pipe Out @ 12 O'Clock

Pipe Material: **Clay** ☐ Pipe Lined

Invert Depth: **9.52** (ft.) Flow Characteristics: **Slow**

Deposits: ☒ None ☐ **Mud** ☐ Sludge ☐ **Debris** ☐ Grease

Infiltration: **None** Pipe Seal Cond: **Sound**

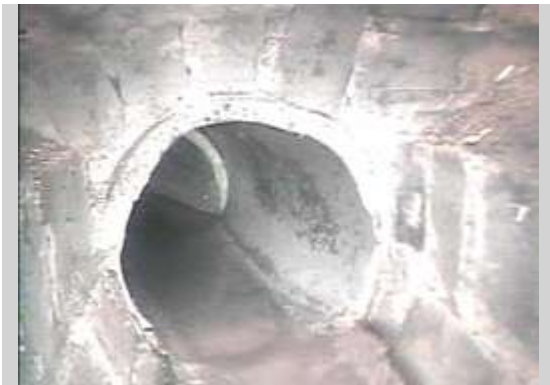
10 in. Circular Gravity Sewer Pipe In @ 5 O'Clock

Pipe Material: **Clay** ☐ Pipe Lined

Infiltration: **None** Pipe Seal Cond: **Sound**
